NBSIR 77-1288 (NASC-Navy)

Stress Corrosion Behavior of K01-T7 Aluminum Alloy Castings

September 1977

Prepared for
Naval Air Systems Command
Department of the Navy
Washington, D. C. 20360

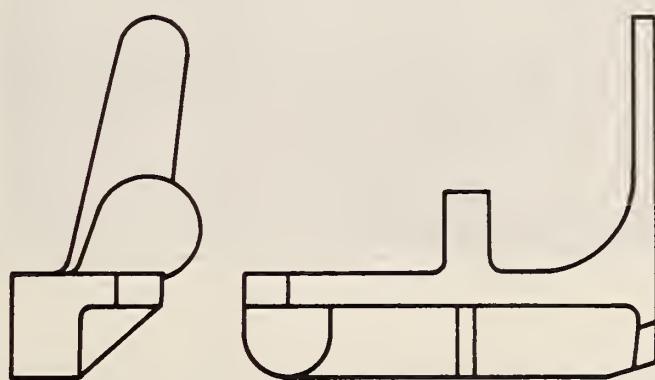
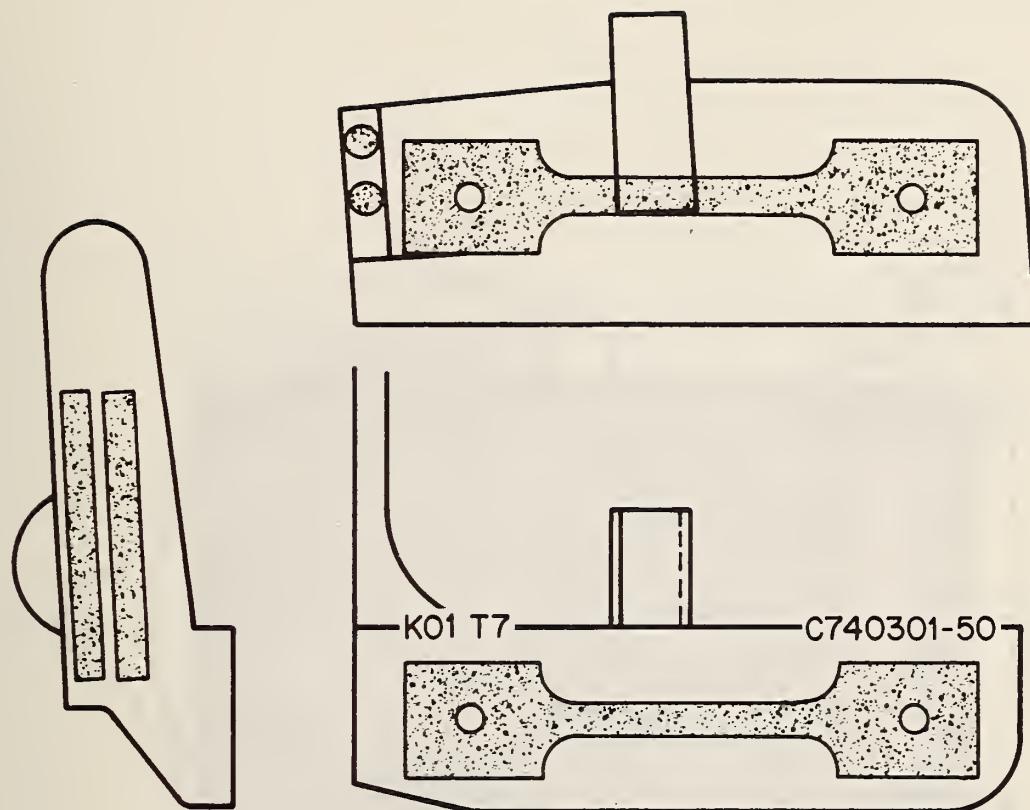
Four test specimens were prepared from each of the two bracket castings (part C740301-50). Two flat stress corrosion specimens were machined from the base of each bracket and two round tensile specimens were machined from the side of each bracket as shown in Figure 1. Fourteen round tensile specimens were machined from the one aluminum alloy flange casting marked C5T27377. Figure 2 illustrates the position of each specimen obtained from the parent material. All specimens were taken from solid sections of the castings and there were no visual indications of voids or flaws.

Figure 1. Drawing of bracket casting
(C740301-50) showing origin
of test specimens.

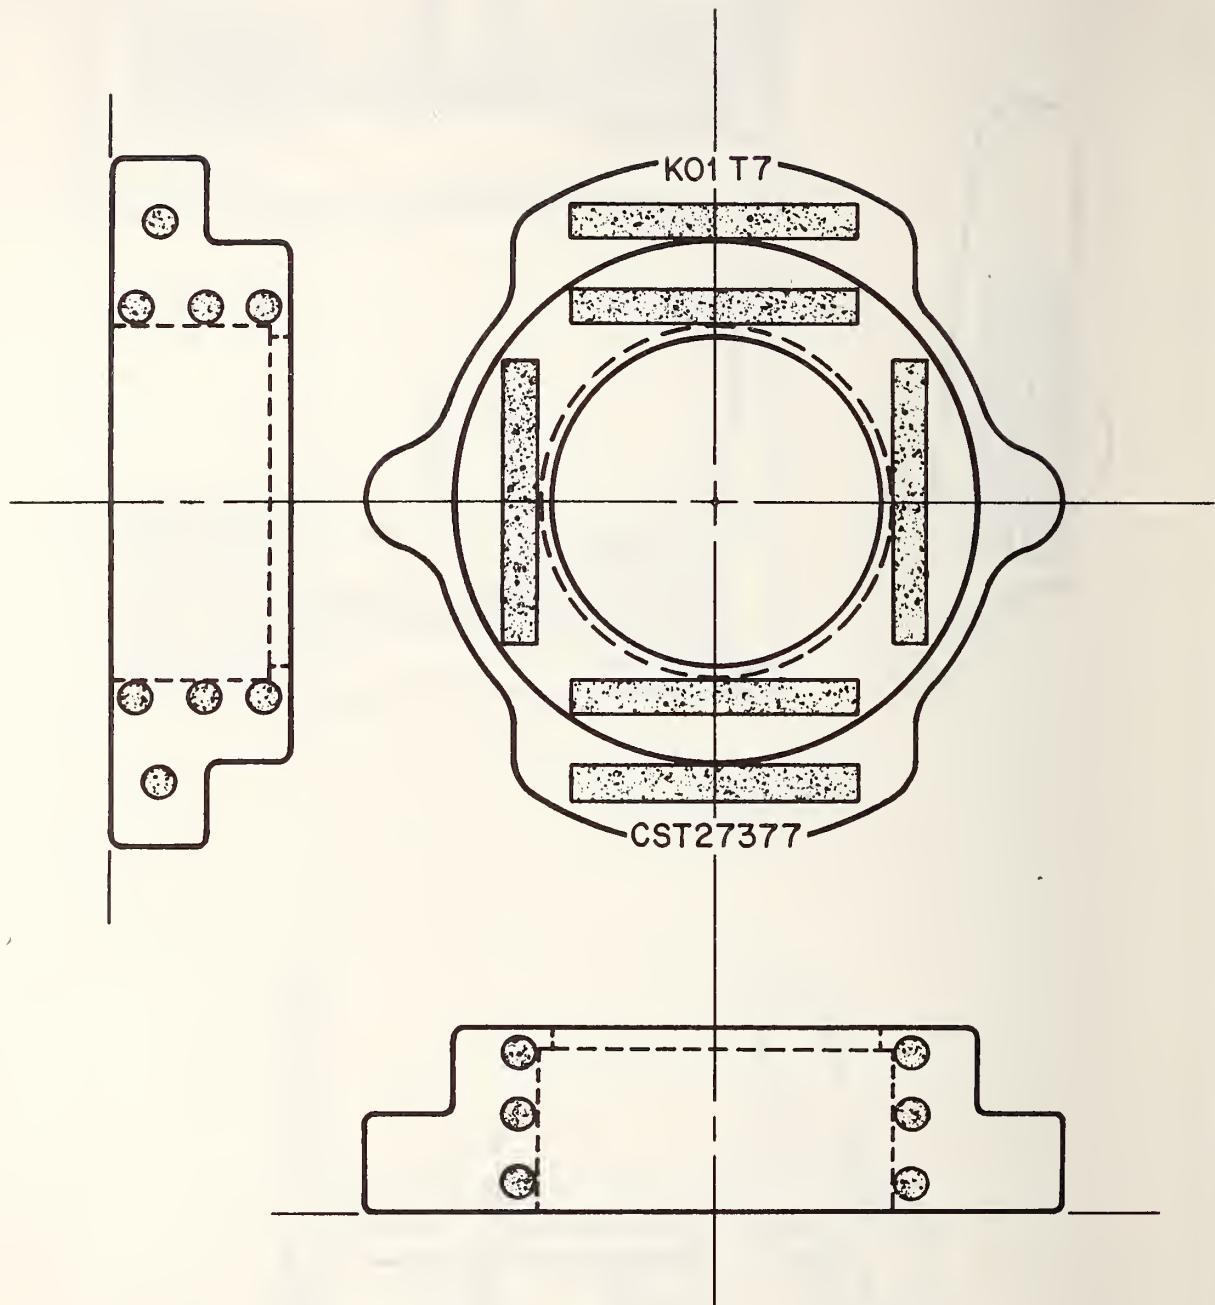
Figure 2. Drawing of flange casting
(C5T27377) showing origin
of test specimens.

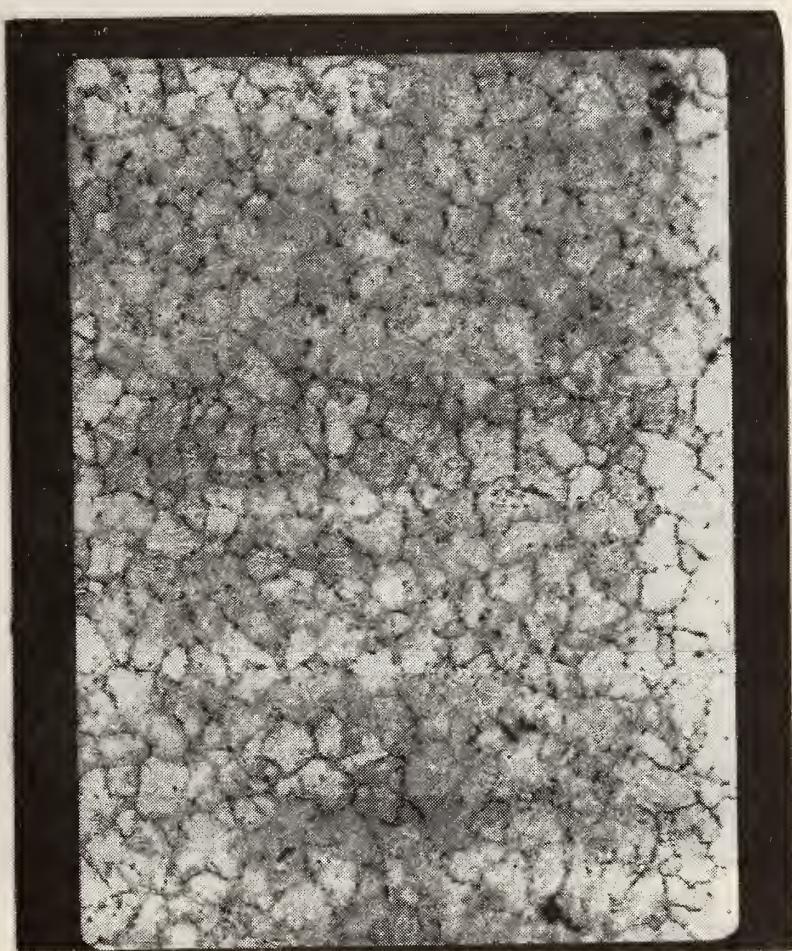
Sections were obtained from areas at and adjacent to the fracture surfaces of the failed specimens for metallographic examination. In general, the microstructure for both specimens revealed a uniform grain size and the presence of intermetallic precipitates at the grain boundaries (Figure 3). Metallographic examination of areas at the fracture showed that the fracture surface was both intergranular and transgranular (Figure 4) with no evidence of secondary cracking.

Figure 3. Microstructure of K01-T7 aluminum alloy. Etched,
Keller's, etch. X50.

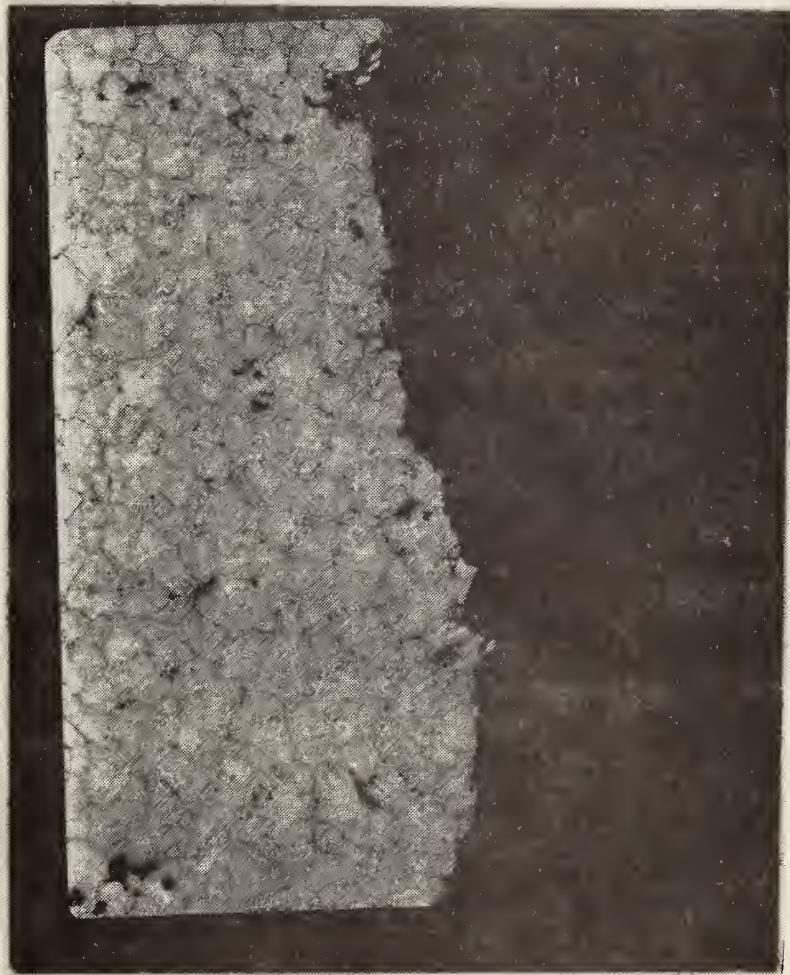
The results obtained from stress corrosion tests on K01-T7 aluminum alloy indicate that the alloy may be subject to stress corrosion. Examination of failed (37 and 249 days) specimens, which had been stressed by the constant load method, showed that the fractures were both transgranular and intergranular in nature. Other specimens stressed by the constant strain method had not failed after 1160 days of exposure. Both of the failures which occurred during exposure in the marine atmosphere were from specimens removed from the brackets. However, these were the only specimens exposed utilizing a constant load system. The alloy also exhibited a considerable amount of shallow surface pitting which was accompanied by heavy adherent gray corrosion products. Since the number of specimens tested was limited by the amount of material available, due consideration should be given to further testing of this alloy under constant load conditions at the same and lesser applied stresses.

Figure 4. Fracture surface of failed K01-T7 aluminum alloy specimen after exposure for 37 days. Fracture is both intergranular and transgranular. Etched, Keller's etch. X50.
